EXPERIMENTAL INVESTIGATION ON REPAIRING OF STEEL PIPES USING COMPOSITE MATERIALS: PART II

Zamzam A. Alshrif, Ramadan O. Saied, Muftah T. Abujelala and M. I. Elarbi

Mechanical Engineering Department
Faculty of Engineering, University of Garyounis
E-mail: Saied972004@yahoo.com.

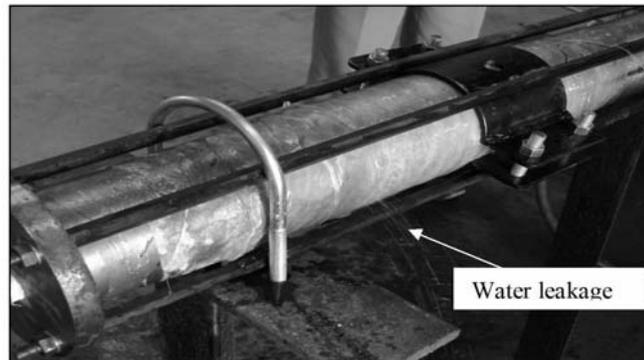
Figures (11 and 12) show failure modes of the failed pipes. It can be seen that the pipes with 20mm and 15mm holes exhibited similar mode of failure called circumferential delamination [6]. This mode of failure occurs when delamination in the region of a hole spreads around the full circumference of the pipe as shown in the Figure (13). It can be seen that over the region of the delamination, the substrate pipe is unloaded and the pressure load on composite repair results in a gap formed between the repair and steel that leads to water leakage from both ends of the pipe.

Figure 11: The circumferential delamination failure mode with defect hole of 20mm.

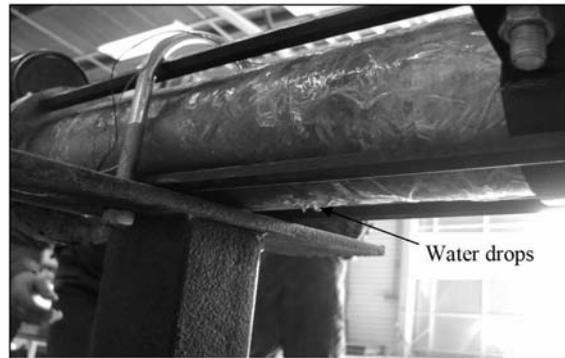
Figure12: The circumferential delamination failure mode with defect hole of 15mm.

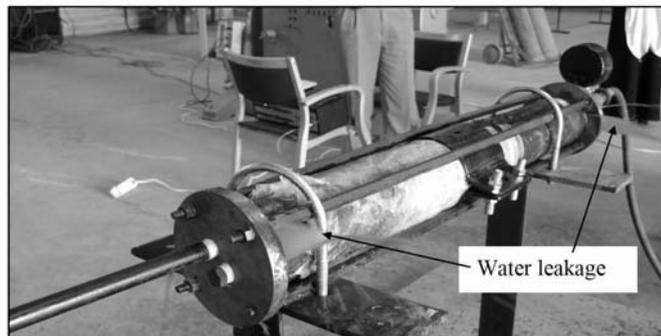
Figure (14) shows the pipe failed at its flanges rather than the repaired region due to the extremely high pressure, about 200 bars. This demonstrated that the bolted clamp worked efficiently without any leakage of water.

Figure 14: A pipe failed from its end flanges

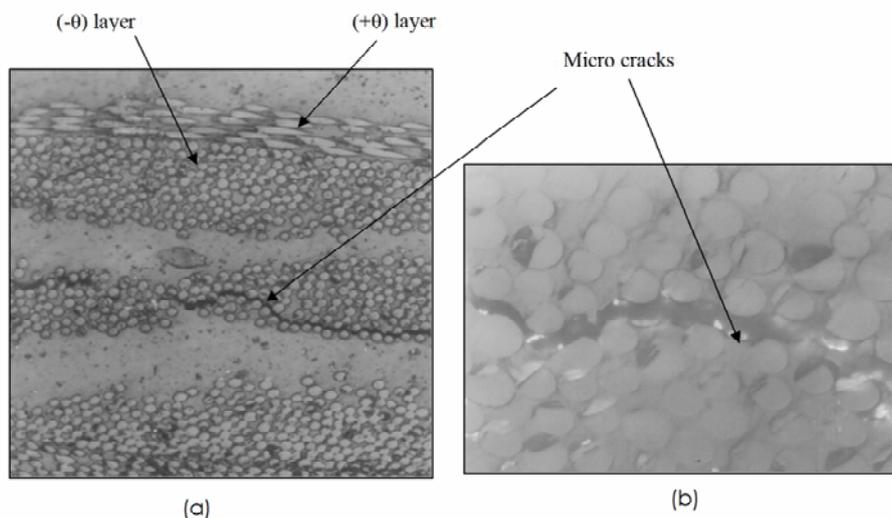
Figure (15a and b) shows optical micrographs of polished sample from the failed pipe. The small circles represent the fibre aligned unidirectionally at an angle of $(+\theta)$ to the pipe axis and ovoid fibre were at an angle of $(-\theta)$ with pipe axis. The tiny black

lines are matrix cracks. It can be seen that the crack appeared and travelled through the (+ θ) ply. This type of cracks was more frequently observed in all failed pipes. Usually, these cracks grew in length and increased in number with an increase in creaking noise as the pressure intensified, finally spread over the repaired region. The formation of these cracks is probably related to the effect of radial and longitudinal stresses and to matrix strain to failure which is lower than that of fibre. These cause debonding at the fibre/matrix interface and resin cracking.

Figure 15: Optical micrograph of polished sample from the composite layer repaired pipe. (a) Magnification X 20 and (b) magnification X 50

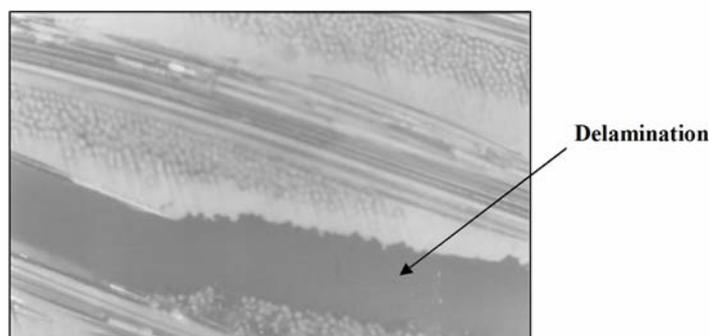
Figure (16) shows a delamination which occurred between two plies as a result of interlaminar microcracks. The delamination may lead to the ply separation. The occurrence of delamination may cause continuous crack paths which increase the probability of weepage occurring by increasing the length of cracks crossing by other cracks [17].

Figure 16: A delamination between the layers (magnification X20)

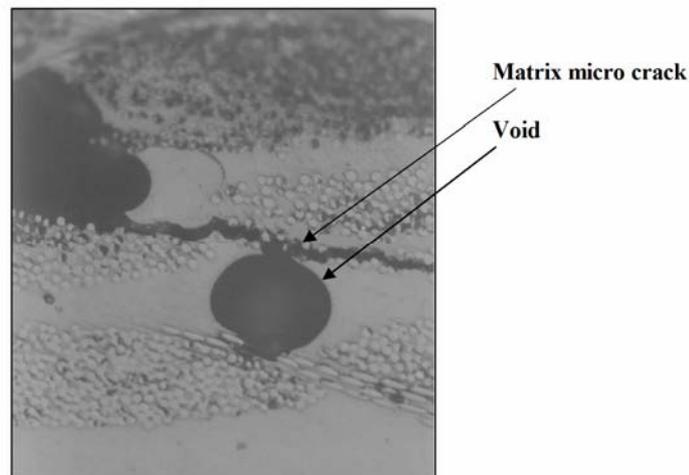
Figure (17) illustrates a microcrack induced by a micro-void (black spots) in the interface region between two plies. It can be observed that the microcracks initiated and propagated from one void to the other. One possible explanation for these cracks is that

the voids which were entrapped during the repairing process caused a stress concentration in the laminate like a plate with an open hole.

Figure 17: A micro crack propagates in a laminate from one void to another
