# THE SUBSURFACE CHARACTERISTICS OF PEARLITIC RAIL STEELS FOLLOWING SERVICE IN UK

F. A. M. Alwahdi A. Kapoor\* and F. J. Franklin\*

## ABSTRACT

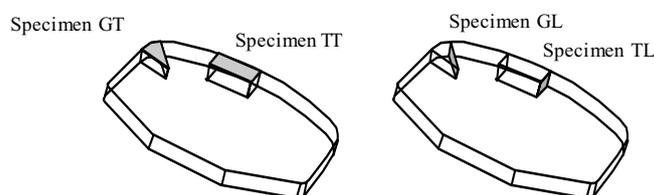
**Figure 1: A schematic representation of a rail head, showing the locations of specimens relative to the rail section.**

Specimens were cut from the head and gauge corner of rails. The position of the specimens in relation to the rail is shown in Figure (1). Four samples were cut from each rail allowing both longitudinal and transverse deformation to be observed. These samples were top transverse (TT), top longitudinal (TL), gauge transverse (GT) and gauge longitudinal (GL). The samples were mounted in Bakelite, diamond polished down to a particle size of 1 µm and etched with a 2% nital solution (nitric acid in ethanol) for 10 seconds to reveal the microstructure. This is the standard metallographic preparation technique for pearlitic rail steel.

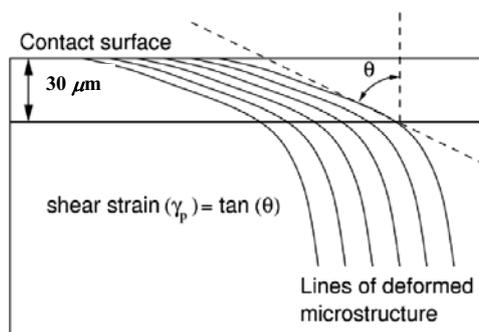
**Figure 2: Shear strain measurement technique. Deformation of the steel produces alignment of its microstructure in the direction of deformation. Measuring the angle of these deformation lines at 30  $\mu\text{m}$  below the surface gives the shear strain at this depth. Further depths are sampled in a similar way [17].**

boundaries, twin boundaries and lamellae can be utilized to provide information about the deformation characteristics of layers below the surface and optical microscopy was sufficient for this purpose. The total plastic shear strains were estimated by measuring the angle ( $\theta$ ) of the deformed grain boundaries and deformed pearlitic lamellae relative to the normal to the contact surface. Measurements were taken on micrograph images that were transferred to a PC equipped with the image analysis software (g3data) [16]. These optical images were taken by using POLYVAR-MET/2.GA/E-85/01 camera to reveal the shear deformation in the region between the worn surface and the undeformed material deeper into the rail. Figure (2) shows a schematic representation of this method. Shear strain ( $\gamma_p$ ) was calculated as the tangent of the angle ( $\theta$ ). This method of shear strain measurement was used by Tyfour et al. [17] and was found to give a reasonably accurate measure of strain. Cimenoglu [18] used the same method to determine effective plastic strain from the shear angle of pearlite bands at depths less than 20  $\mu\text{m}$  from the worn surface. Alpas et al. [1] also used a similar technique to measure displacement of a marker platelet, inserted in a test specimen surface, during sliding contact testing.

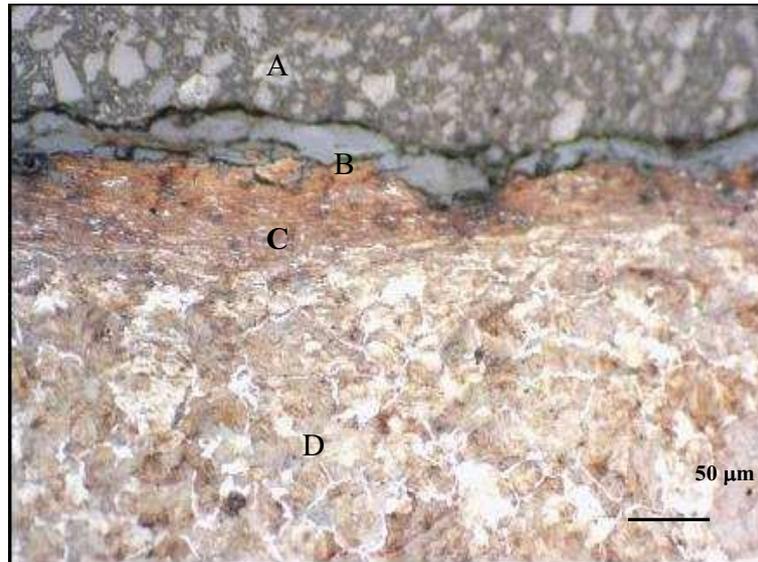
**Figure 3: Optical micrograph of longitudinal section of rail gauge face site (TL) for rail P1. Moving down the picture there is (A) sample mounting material, (B) rail surface debris, (C) plastically deformed steel, and (D) at the bottom the undeformed steel microstructure is visible.**

Considering rail P1, examination of specimen GL (gauge corner, longitudinal deformation) revealed shear deformation under the worn surface with a visible depth of between 60 and 110  $\mu\text{m}$  depending on the position across the specimen. In specimen TL (top of head, longitudinal), the deformed layer was still present, but with visible thickness reduced to between 50 and 90  $\mu\text{m}$ , as shown in Figure (3). Although wear would continually remove surface material, thereby reducing the remaining depth of plastic deformation, plastic deformation can be in a steady state in only a few contact passes, so wear will not have significantly influenced the depth of deformation observed.

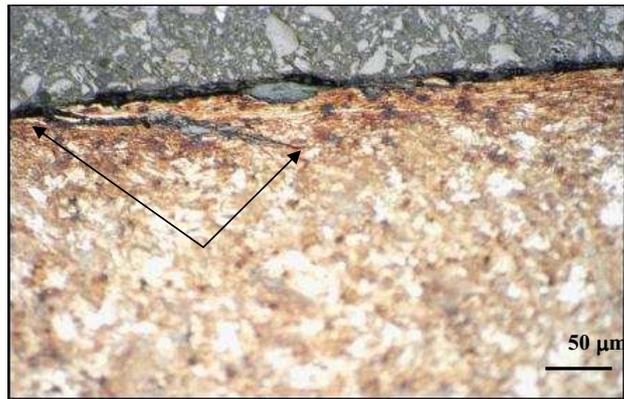
Figure 4: Optical micrograph of longitudinal section of the rail gauge face (GL) for rail P2. Moving down the picture there is sample mounting material, the rail surface containing a crack (with mouth and tip indicated by arrows) at the bottom the undeformed steel microstructure is visible.

Taking rail P2, visible deformation reaches less deeply into the material than for the P1 rail. Figure (4) illustrates this deformation in the longitudinal direction for the rail gauge face and also shows a small surface breaking crack in the rail. Visible deformation reaches depths up to 40  $\mu\text{m}$ , below which the rail steel appeared to be undeformed. The difference in depth to which plastic deformation has reached in the P1 and P2 rails is reflected in the shear strain vs. depth curves for the very near surface material plotted in Figure (5). From these results, it is clear that the strain accumulation of rail P2 was lower than for rail P1. Rail P2 also showed less plastic deformation at the surface. This could be a result of rail grinding in track, whereby the surface layer of the rail head is removed (this is the material in which the build up of plastic deformation is highest) and fresh material is exposed to the running wheel.

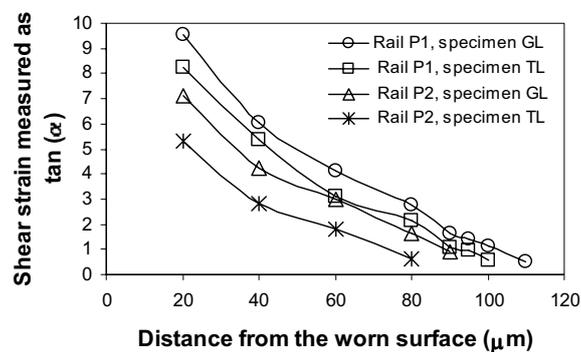
Figure 5: Longitudinal plastic shear strain vs. depth, very close to the surface of the P1 and P2 rails. Specimen TL indicates the top of rail sample and specimen GL indicates the gauge face sample.

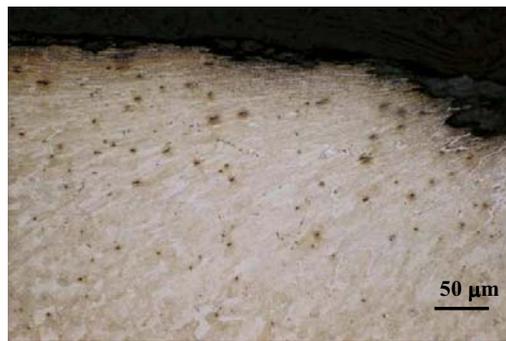
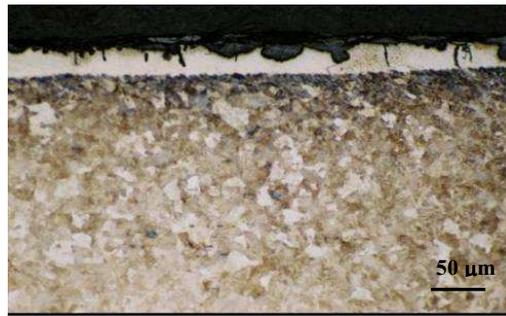
**Figure 6: Microstructure of P3 rail material under the worn surfaces; (a) transverse section of the rail gauge (GT), moving down the picture there is sample mounting material and the plastically deformed layer below the running surface; (b) longitudinal section of the top rail face (TL), moving down the picture there is sample mounting material, a narrow band of WEL and the deformed steel microstructure is visible.**

Plastic deformation reaching a depth of 150 μm was observed in the surface of rail P3 at the top transverse specimen. The plastic deformation in the gauge corner of the rail can be seen in Figure (6a) where the plastic deformation exceeded the depth of that found on the rail head by 30 μm. The longitudinal cross section through rail P3 revealed a white etching layer (WEL) in patches of about 10μm thickness, although the thickness was not uniform over the width of the rail surface (see Figure (6b)). The WEL reached a maximum depth of approximately 40 μm and contained small cracks over the full width of the running surface. The composition and the structure of the WEL remains the subject of research, but investigations [12-15] suggest that there is no common composition or structure for all white etching layers.

It was observed that thin white surface layer, frequently called white etching layer (WEL), with 10 to 40  $\mu\text{m}$  thicknesses. See Figure (6b) it may be produced by the accumulation of plastic deformation. The surface white etching layer has a close relationship to plastic deformation, and also regarded as dissolution of cementite during severe plastic deformation, and transformation of the supersaturated  $\alpha\text{-Fe}$  into martensitic structure [28]. The WEL seems to reach hardness values up to  $\sim 1040$  HV. This high hardness can be linked to the presence of martensite [29]. Beneath this layer a region of deformed pearlite is observed. The hardness of this deformation region is almost 1.5 times the bulk hardness. The increase in the hardness depends on the rise in the work hardening of the contact surface as the carbon content increases. The structure below the white layer exhibits deformed and broken cementite lamellae. The hardening process is caused by decreased interlamellar spacing, which sufficiently has increased hardness and yield stress of the material.

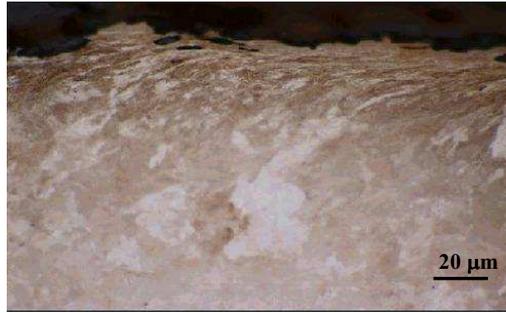
**Figure 7a: Optical micrograph of longitudinal section of the rail gauge face (specimen GL) for rail P4. Moving down the picture there is sample-mounting material; large deformed steel microstructure is visible**

Metallographic examinations of longitudinal sections from rail P4 revealed shear deformation beneath the worn surface of the gauge corner (specimen GL). As shown in Figure (7a), the microstructure of the steel consisted of ferrite and cementite bands elongated in the rolling direction. The variation of shear strain with depth from the worn surface of both rails P3 and P4 are plotted in Figure (7b), where it can be seen that the plastic deformation at the gauge corner is greater than that at the crown of each rail, and that the deformation extended to larger depth. Figure (8) shows the gauge longitudinal cross section (specimen GL) of the unused rail sample (P5). It shows two layers: a decarburised surface layer (~120 μm thickness) with small grain size, and a bulk material layer with a microstructure characteristic of pearlitic, with no deformation. The decarburised layer was very soft and contained large amount of ferrite. There is a strong tendency for carbon to be lost from the surface of steel during heat treatment and this is one of the oldest most persistent problems in ferrous production metallurgy. Decarburisation lowers resistance to wear and localized patches of decarburisation can lead to soft spots. Weakening of the surface as a result of decarburisation may favour the initiation of fatigue cracks [19].

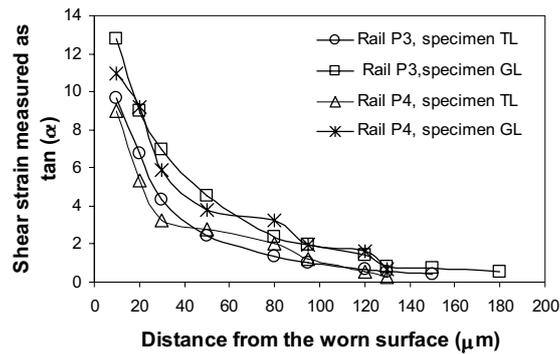
**Figure 7b: The variation of shear strain with distance from the worn surface for rails P3 and P4.**

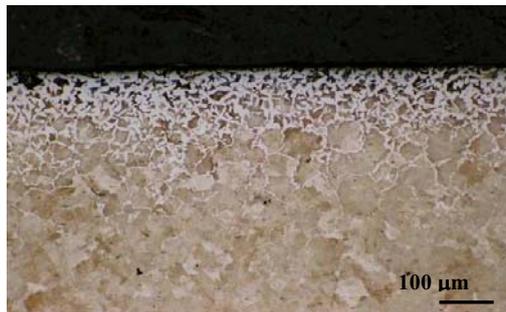
**Figure 8: Optical micrograph of longitudinal section of the rail gauge face (GL) for new rail P5. Moving down the picture there is sample mounting material, top rail surface containing a small grain size with large amount of ferrite and the bulk material microstructure.**

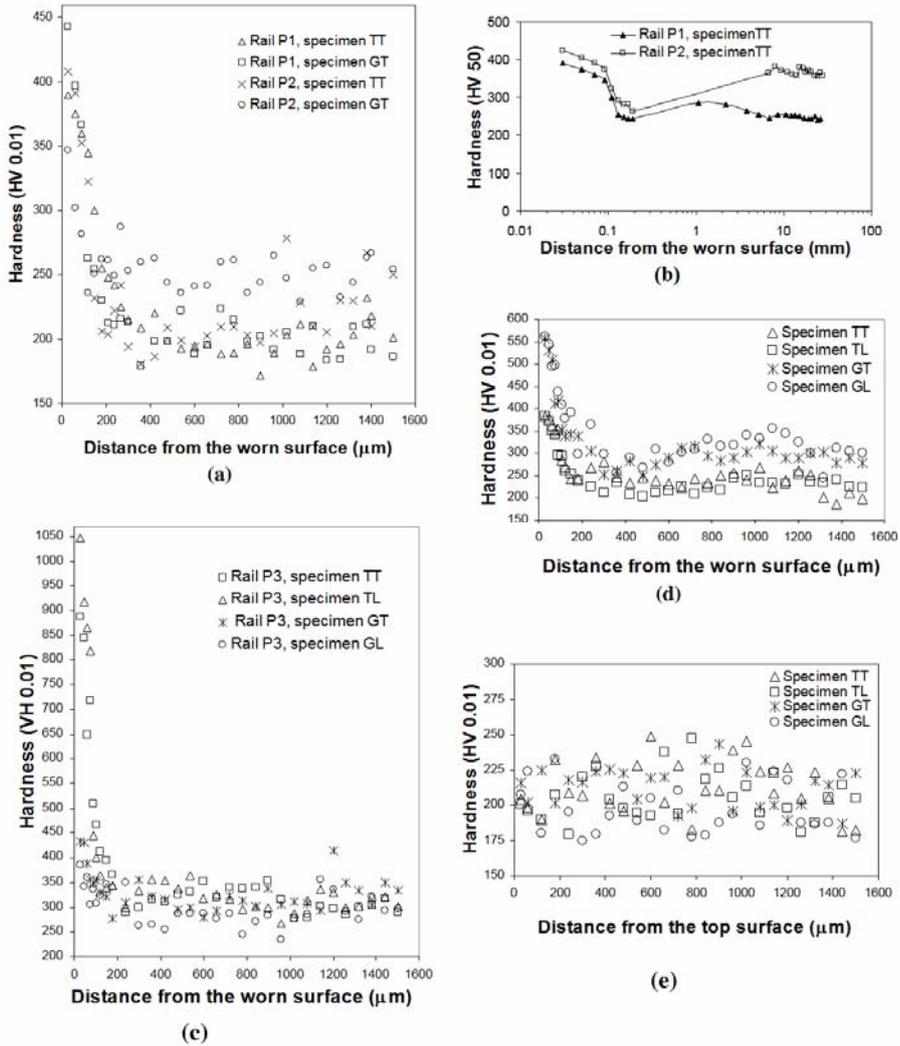
**Figure 9: Rails hardness variation with depth (a) of rails P1 and P2 with 10g load and 1.5 mm depth (b) of rails P1 and P2 with 50 kg load and 27 mm depth. (c) of rail P3 (d) of rail P4 (e) for the new rail P5.**

Profiles of hardness from the surface down into the undeformed (by visual inspection) material are shown in Figure (9a) for all the samples examined. The P1 and P2 rail heads had a hardness of 210HV and 245HV respectively. The increase in hardness at the surface of each rail steel (around 1.8 and 1.6 times the bulk rail head hardness respectively) can be attributed to work hardening. Although the hardness differential between the materials was reduced as both materials hardened close to the surface, the ranking of the steels remained the same throughout.

Looking at the hardness profile at greater depth for the P2 steel, an increase in the spread (250-270 HV) of the results was observed. Figure (9b) shows the hardness variation with depth up to 27 mm for P1 and P2 rail steel samples. Near surface measurement are taken from Figure (9a) (with 10g load) but a 50kg load is used at greater depths. A log scale is used to ensure all data are visible. Hardness tests at greater depths revealed a region of increased hardness at between 1 and 10 mm deep. This is to be expected, and is produced by the action of the wheel contact as a whole. The near surface plastic deformation is produced by the action of micro roughness [20].

The hardness of the sub- surface layers was in the range of 250-350 HV for all the samples. Profiles of hardness from the surface down into the visible undeformed material for rail P4 are shown in Figure (9d) for all the samples examined. The Figure shows that increase in hardness of all the samples around 200% with respect to the original hardness at the worn surface. This can be attributed to work hardening. Figure (9e) shows the microhardness measurements from the top surface of the new rail for all the samples examined. The near surface region is softer than the bulk of the material because of the decarburisation layer which located near to the new rail surface.

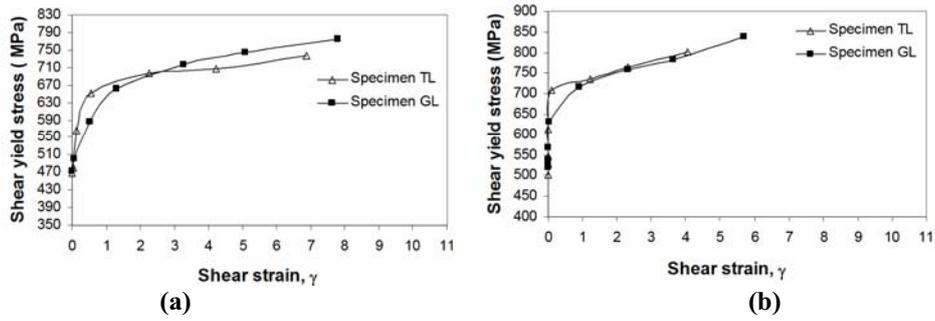
Figure 10: Shear-stress shear-strain curves for (a) rail P1, (b) rail P2.

Where *HV* is Vickers hardness in MPa (conversion is required from the value expresses normally in  $\text{kg}/\text{mm}^2$ ). Results are plotted for the two rails respectively in Figure (10).

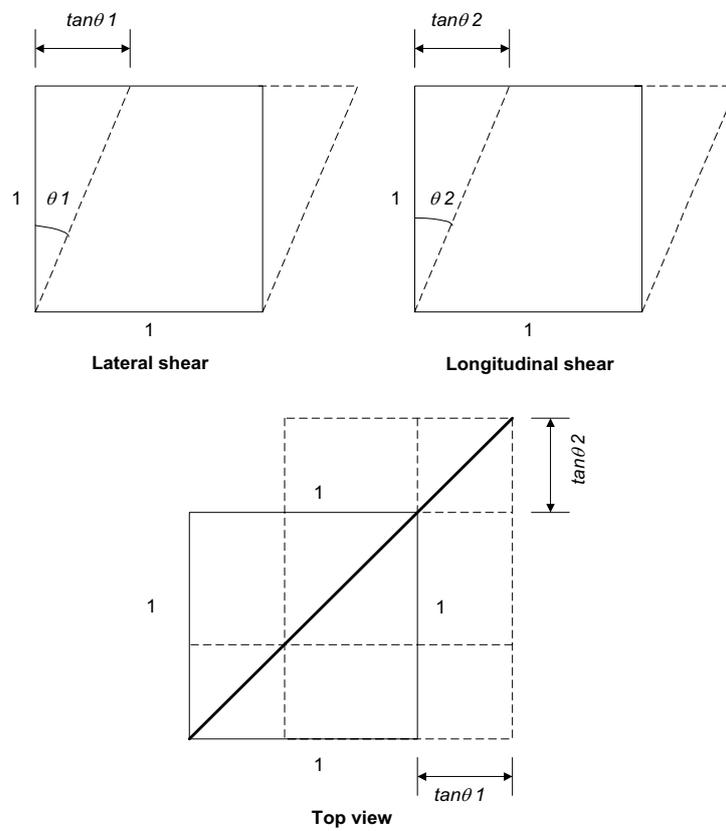
Figure 11: Schematic illustration of the shear strain accumulation in the lateral and longitudinal directions of an element cut from a rail.

The value of the equivalent shear strain ( $\gamma$ ) corresponding to the shear yield stress at different depth below the worn surfaces for the P3 and P4 rails were calculated by using equation (8). As an approximation, it was assumed that the change of an element of rail material in the lateral and longitudinal directions as shown in Figure (11).

Because the shear strain take place in two directions (lateral and longitudinal directions) when the load is applied (wheel pass the rail in railway track). Let us take a small element of isotropic material cut from a rail (see Figure (11)). The original shape of the element (shown by the solid lines) is a square having sides of length  $1 \mu\text{m}$  in the  $x$  and  $y$  directions, respectively. The final shape of the element is shown by dashed lines. The elongation of the element in the lateral direction is  $(1 + \tan\theta_1)$  while the elongation of the element in the longitudinal direction is  $(1 + \tan\theta_2)$  where  $\theta_1$  and  $\theta_2$  the angle of the deformed grain boundaries and deformed pearlitic lamellae relative to the normal to the contact surface in the lateral and longitudinal directions respectively.

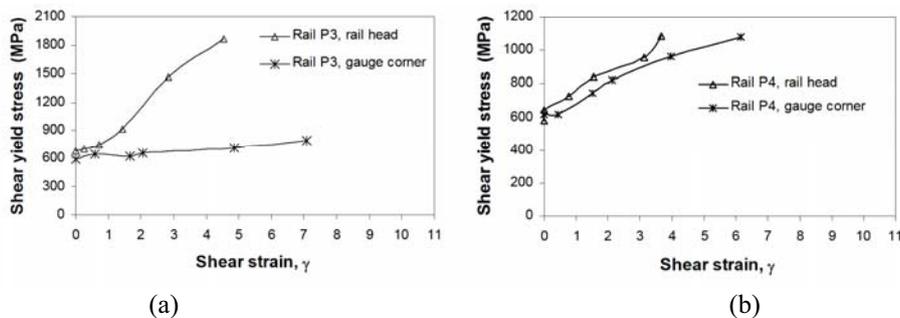
Figure 12: Shear-stress shear-strain curves for (a) rail P3, (b) rail P4.

Where  $\gamma_1$  and  $\gamma_2$  are the shear strain in the lateral and longitudinal directions respectively. These calculations have been done for both rails (P3 and P4) and the shear stress-strain curves for the deformed layer is shown in Figure (12).

The shear yield stress of the material changes under rolling-sliding conditions due to strain hardening of the material. As the material strain hardens, the effective shear yield stress increases and the material is able to support larger loads without plastic flow. The result is an increase in the shakedown limit. The material hardens very rapidly with increased strain for rails P1, P2 and P4, but for rail P3 there is a high maximum of work hardening at top longitudinal (TL) sample. This is because of the high hardness of the white etching layer (WEL) which lies on top of the rail surface.
