EXPERIMENTAL INVESTIGATION ON REPAIRING OF STEEL PIPES USING COMPOSITE MATERIALS: PART II

Zamzam A. Alshrif, Ramadan O. Saied, Muftah T. Abujelala and M. I. Elarbi

Mechanical Engineering Department
Faculty of Engineering, University of Garyounis
E-mail: Saied972004@yahoo.com.

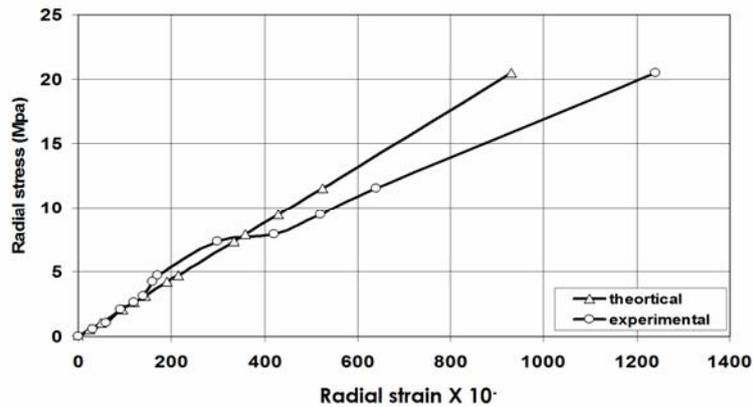
Figures (7, 8 and 9) show the experimental and theoretical radial stress versus radial strain curves for pipes with defect holes of 20mm, 15mm, and 10mm. It can be observed that all the curves exhibited the same manner. The experimental curves are linear in the early stages and then exhibited non-linear behaviour up to failure, while the theoretical curves are linear up to failure. The non-linearity of the experimental curves is probably related to the matrix cracking in composite layers. The non-linearity due to matrix cracks is well documented in the literature [13-15]. The immediate effect of micro cracks is to cause degradation of the stiffness due to redistribution of stresses and variation of strain in cracked laminate [16]. The matrix cracks can induce delamination which leads to fibre breakage or provides pathways for the entry of pressurized liquid between the layers and may lead to laminate failure. Good correlations between the two curves can be observed at the early stages of loading. However, discrepancies between

the theoretical and experimental curves can be seen at high strain to failure. This is probably due to further damage in the composite layer.

Figure 7: Radial stress versus radial strain for a pipe with 20 mm defect hole

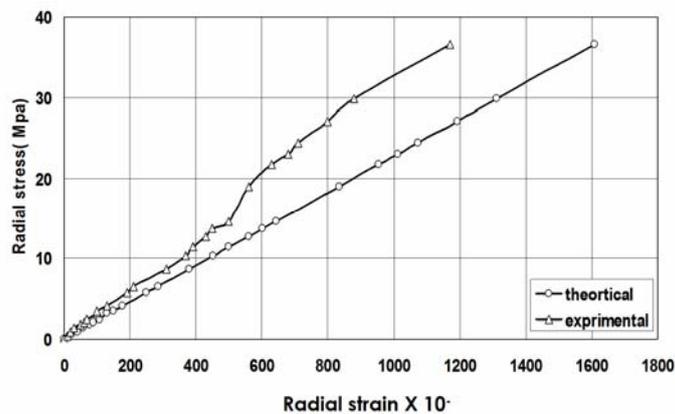
Figure 8: Radial stress versus radial strain for a pipe with 15 mm defect hole

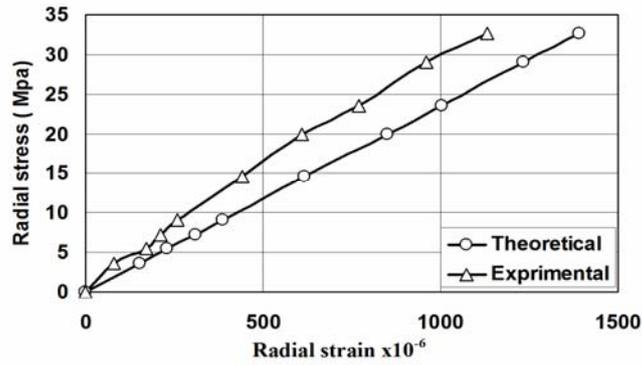
Figure 9: Radial stress versus radial strain for a pipe with 10 mm defect hole

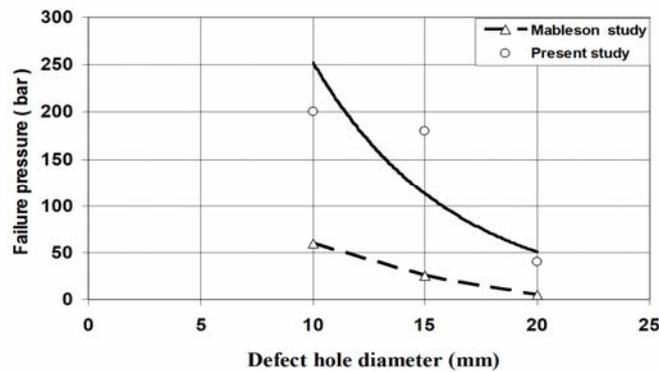
Figure (10) shows a comparison between the present study and Mableson's study [6] for defect hole diameter versus the failure pressure for the failed pipes. Clearly, it can be seen, in both studies, that the failure pressure decreases rapidly with increasing hole diameter. The failure pressure of clamped pipes increases by about 4 times than that of unclamped pipes. This indicated that the clamp works efficiently for defect holes.

Figure 10: A comparison between the present study and Mableson's study [6] for defect hole diameter versus the failure pressure for the failed pipes

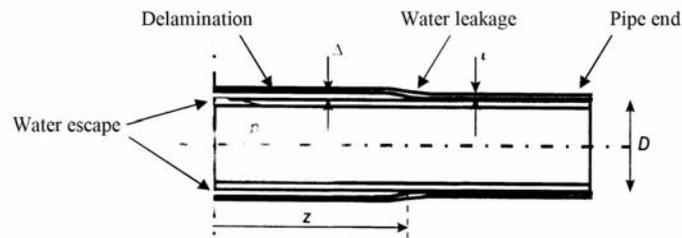
Figures (11 and 12) show failure modes of the failed pipes. It can be seen that the pipes with 20mm and 15mm holes exhibited similar mode of failure called circumferential delamination [6]. This mode of failure occurs when delamination in the region of a hole spreads around the full circumference of the pipe as shown in the Figure (13). It can be seen that over the region of the delamination, the substrate pipe is unloaded and the pressure load on composite repair results in a gap formed between the repair and steel that leads to water leakage from both ends of the pipe.

Figure13: A schematic diagram of the circumferential delamination mode [6]
